**Flood Control Project Maintenance
Levee Inspections**

Maintenance Issue Types Only, Levee Inspection Report By Mile - Fall 2018

Sutter Maintenance Yard East-West Interceptor

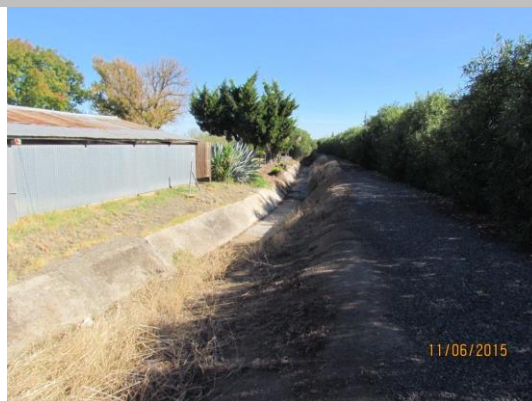
Photo 1 of 2 : FA_2018_ST0020_213_4_20180905_00004.jpg

LM Start	0.62	Rating **	U	Issue No.	4
LM End	0.65	Issue Type +	Ma	Location *	WS
Category	Earthen Levee			GPS Latitude/Longitude	
				Start	End
Item	Erosion / Bank Caving			39.171292°	39.171232°
				-121.748868°	-121.748175°
DWR ID	DWR_NA0020_01_s_2012_4				
Comment Code					
E2 : Schedule repair of erosion site prior to the next inspection.					
Inspector Comment					
Repair the erosion along the concrete ditch.

View the erosion along the concrete ditch.

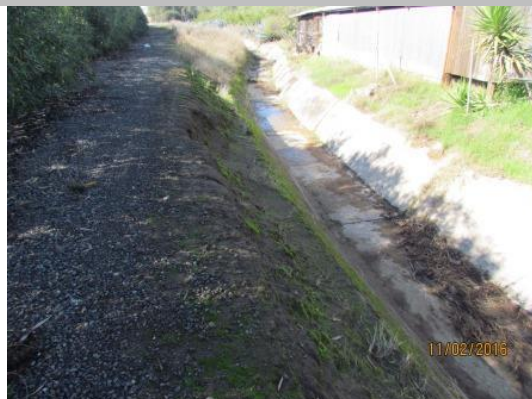
Photo 2 of 2 : FA_2018_ST0020_213_4_20180905_00005.jpg

Another view the erosion along the concrete ditch.

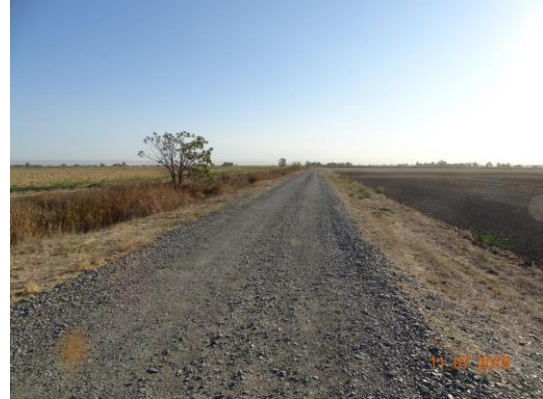
Photo 1 of 1 : FA_2018_ST0020_213_8_20181113_00023.jpg

LM Start	1.36	Rating **	A	Issue No.	8
LM End	1.60	Issue Type +	Ma	Location *	LS
Category	Earthen Levee			GPS Latitude/Longitude	
				Start	End
Item	Vegetation			39.171188°	39.171110°
				-121.734652°	-121.730225°
DWR ID	DWR_ST0020_01_f_2017_8				
Comment Code					
V1 : Control annual grass and weeds on the levee slopes and easements.					
Inspector Comment					
The vegetation was mowed along both slopes.

View of no vegetation along both slopes.

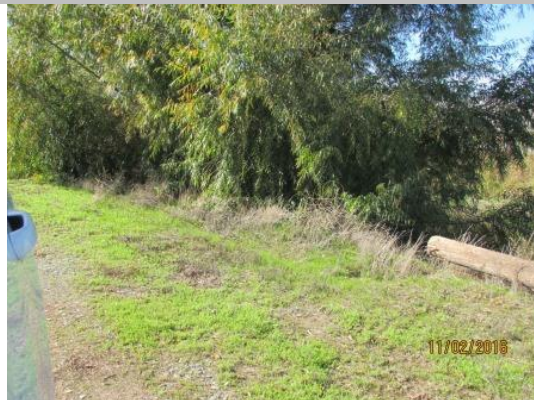
Photo 1 of 1 : FA_2018_ST0020_214_31_20180905_00013.jpg

LM Start	0.29	Rating **	M	Issue No.	31
LM End	0.29	Issue Type +	Ma	Location *	WS
Category	Earthen Levee			GPS Latitude/Longitude	
				Start	End
Item	Trim / Thin Trees			39.171008 °	39.171008 °
				-121.721025 °	-121.721025 °
DWR ID	DWR_ST0020_02_f_2016_31				
Comment Code					
T1 : Trim trees to at least five feet above ground level.					
Inspector Comment

View of the overgrown trees blocking visibility and access.

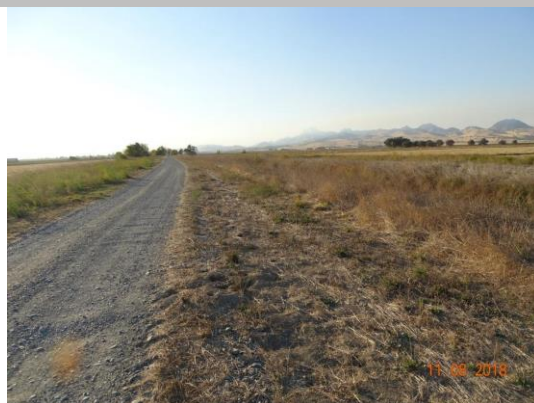
Photo 1 of 1 : FA_2018_ST0020_214_22_20181113_00047.jpg

LM Start	0.54	Rating **	A	Issue No.	22
LM End	0.91	Issue Type +	Ma	Location *	WS
Category	Earthen Levee			GPS Latitude/Longitude	
				Start	End
Item	Vegetation			39.171012 °	39.170918 °
				-121.716450 °	-121.709482 °
DWR ID	DWR_ST0020_02_f_2018_22				
Comment Code					
V1 : Control annual grass and weeds on the levee slopes and easements.					
Inspector Comment					
The vegetation was removed from the waterside slope.

View of no vegetation on the waterside slope.

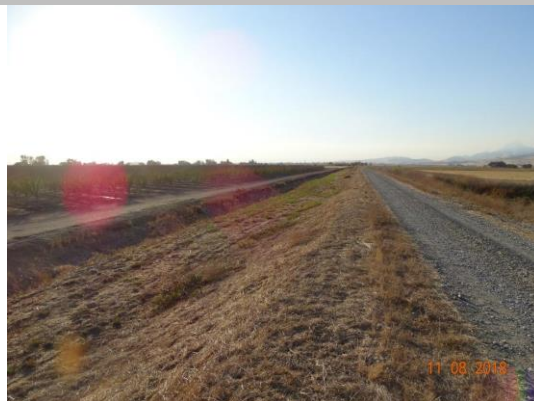
Photo 1 of 2 : FA_2018_ST0020_214_19_20181113_00046.jpg

LM Start	0.54	Rating **	A	Issue No.	19
LM End	1.32	Issue Type +	Ma	Location *	LS
Category	Earthen Levee			GPS Latitude/Longitude	
				Start	End
Item	Vegetation			39.171032 °	39.170853 °
				-121.716310 °	-121.701775 °
DWR ID	DWR_ST0020_02_f_2017_19				
Comment Code					
V1 : Control annual grass and weeds on the levee slopes and easements.					
Inspector Comment					
The vegetation was removed from the landside slope.

View of no vegetation on landside slopes.

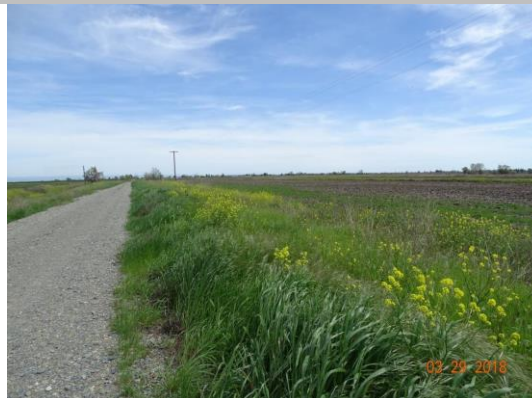
Photo 2 of 2 : FA_2018_ST0020_214_19_20180905_00008.jpg

View of the vegetation along the landside slope.

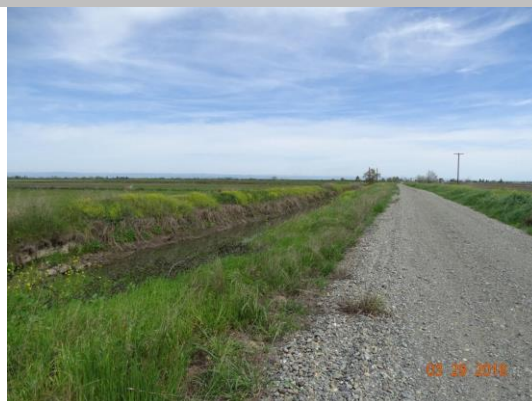
Photo 1 of 2 : FA_2018_ST0020_214_20_20180905_00010.jpg

LM Start	0.95	Rating **	M	Issue No.	20
LM End	1.32	Issue Type +	Ma	Location *	WS
Category	Earthen Levee			GPS Latitude/Longitude	
				Start	End
Item	Vegetation			39.170927 °	39.170853 °
				-121.708675 °	-121.701775 °
DWR ID	DWR_ST0020_02_f _ 2017_20				
Comment Code					
V2 : Remove the wild growth other than native grasses from the levee slopes.					
Inspector Comment					
Remove the vegetation from the waterside slope.

View of the native vegetation on the waterside slope.

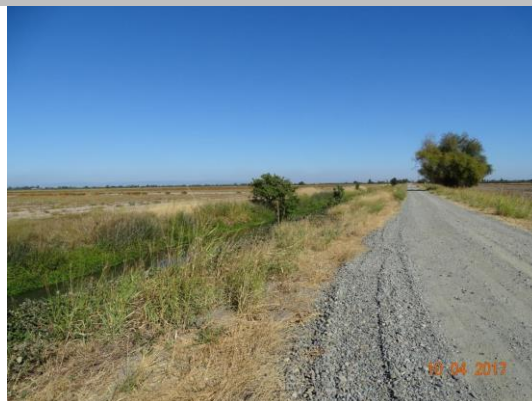
Photo 2 of 2 : FA_2018_ST0020_214_20_20180905_00011.jpg

View of the native vegetation on the waterside slope.
